VCL - 2/34 Mbps PDH Multiplexer

E3, PDH MULTIPLEXER

Product Specifications

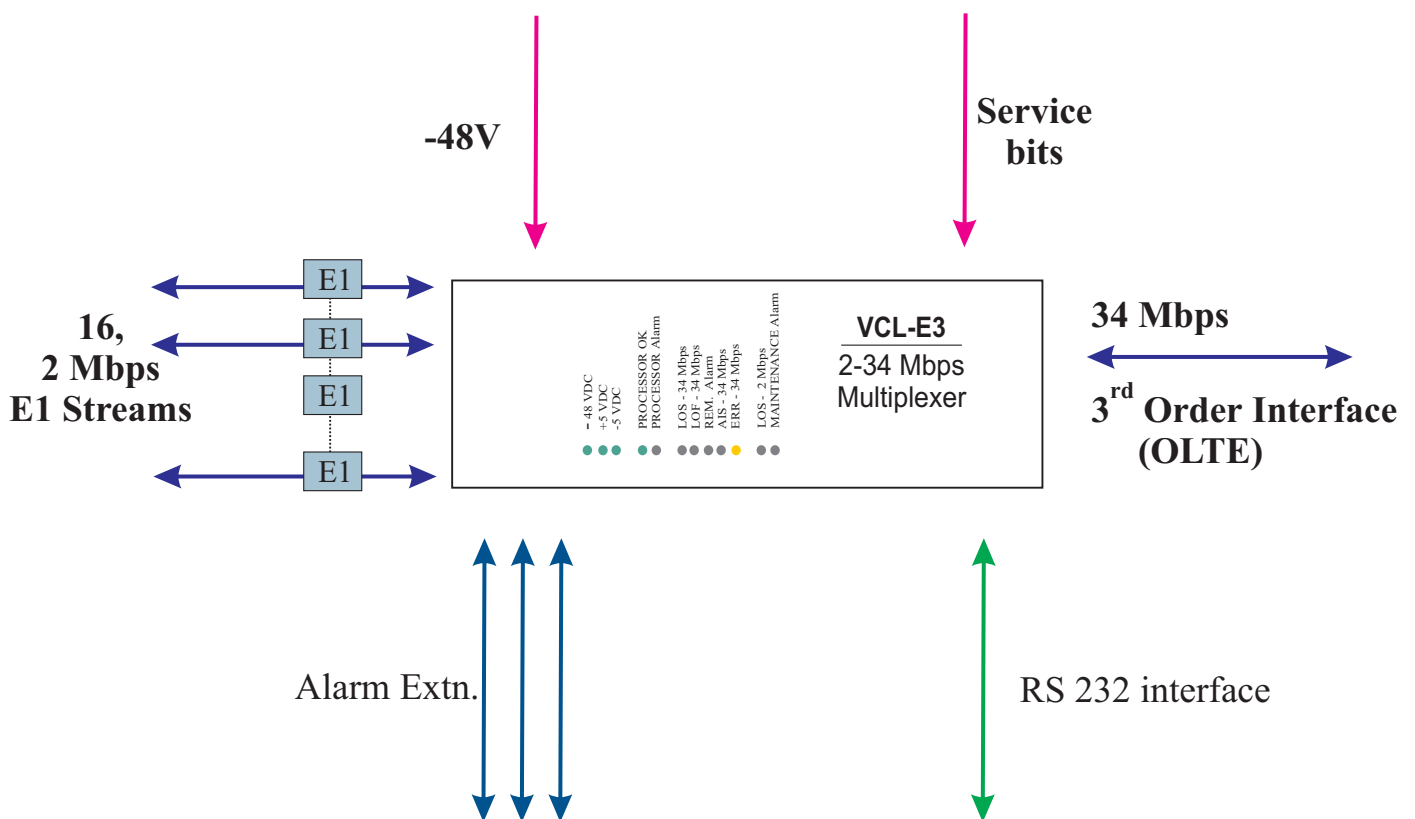
Front View of Shelf

The front panel LEDs provide the following indications:

| L1 - Negative 48V input present | L7- Loss of frame alignment at 34Mbps |
| L2- Positive 5V present | L8- Remote Alarm at 34Mbps |
| L3- Negative 5V present | L9- AIS at 34Mbps |
| L4- Processor healthy | L10- Excessive Error Rate at 34Mbps |
| L5- Processor failed | L11- Loss of signal at 2Mbps |
| L6- Loss of signal at 34Mbps | L12- Prompt Maintenance Alarm |

In addition to the above monitoring facilities, VCL-2/34Mbps Multiplexer is provided with LEDs on the front panel of the multiplexer, which indicate various fault conditions.

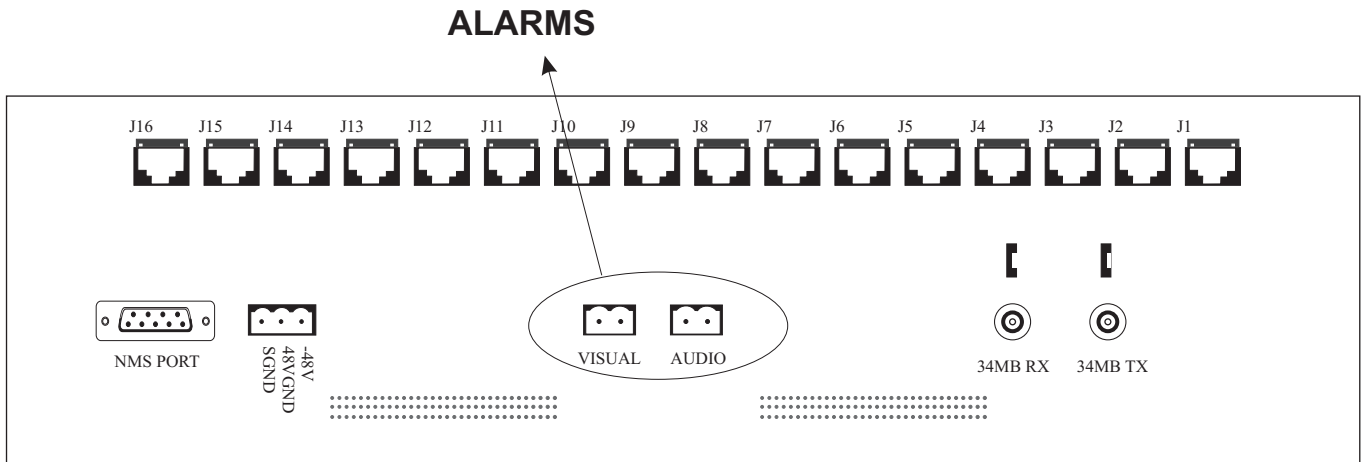
BACK PANEL OF E3, 2/34Mbps Multiplexer RJ-45 Version

- 16, primary rate, 2Mbps, 120 balanced interface
- 1, third order, 34Mbps, 75 unbalanced interface
- -48V input for VCL-2/34 on-board power supply
- RS232 interface for connection to Network Management System, used for configuration and monitoring of the VCL-2/34 multiplexer.
- 2 alarm extensions for visual and audible alarms.
